# **INDOOR AIR QUALITY ASSESSMENT**

**Department of Employment and Training  
Route 114-Stadium Plaza  
Lawrence, Massachusetts**

Prepared by:  
Massachusetts Department of Public Health  
Bureau of Environmental Health Assessment  
Emergency Response/Indoor Air Quality Program  
June 2003

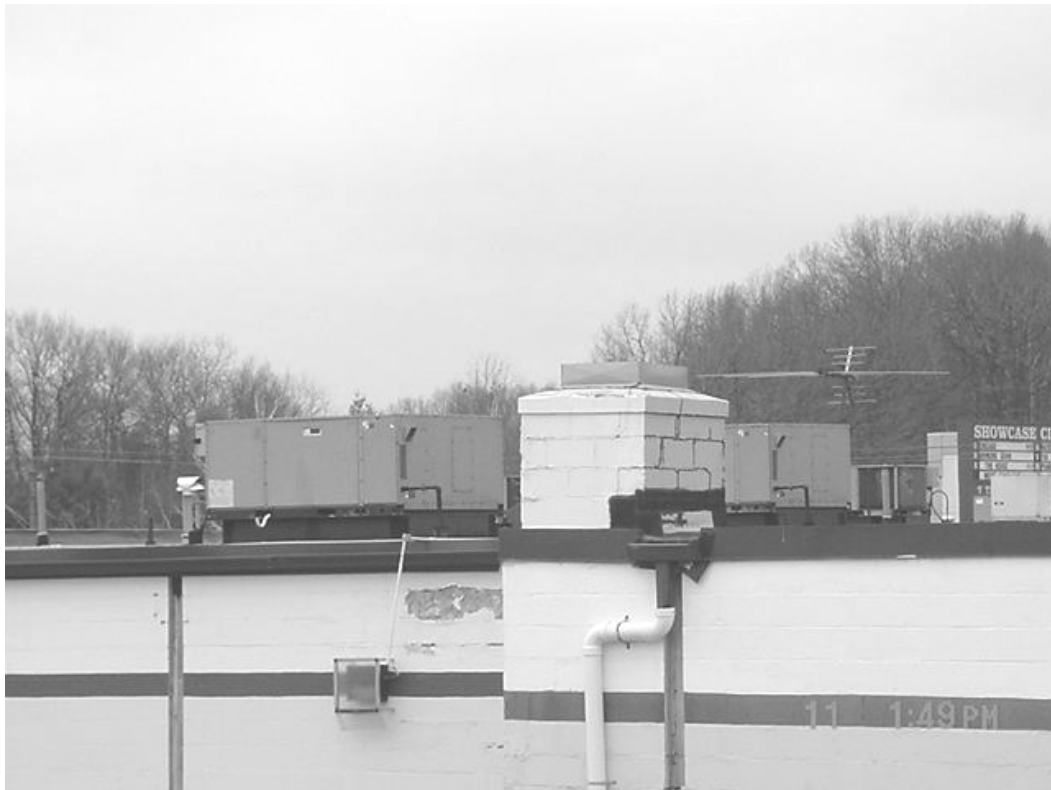
**Picture 1**

It can be seen from the tables that carbon dioxide levels were elevated above 800 ppm in all occupied areas surveyed, indicating inadequate air exchange. Mechanical ventilation is provided by rooftop air handling units (AHUs) (see Picture 1). Fresh air drawn into outside air intakes and is distributed via ductwork connected to ceiling mounted air diffusers (see Picture 2). Exhaust ventilation is provided by ceiling-mounted exhaust grills that are ducted back to AHUs (see Picture 3).

**Rooftop Air Handling Units**

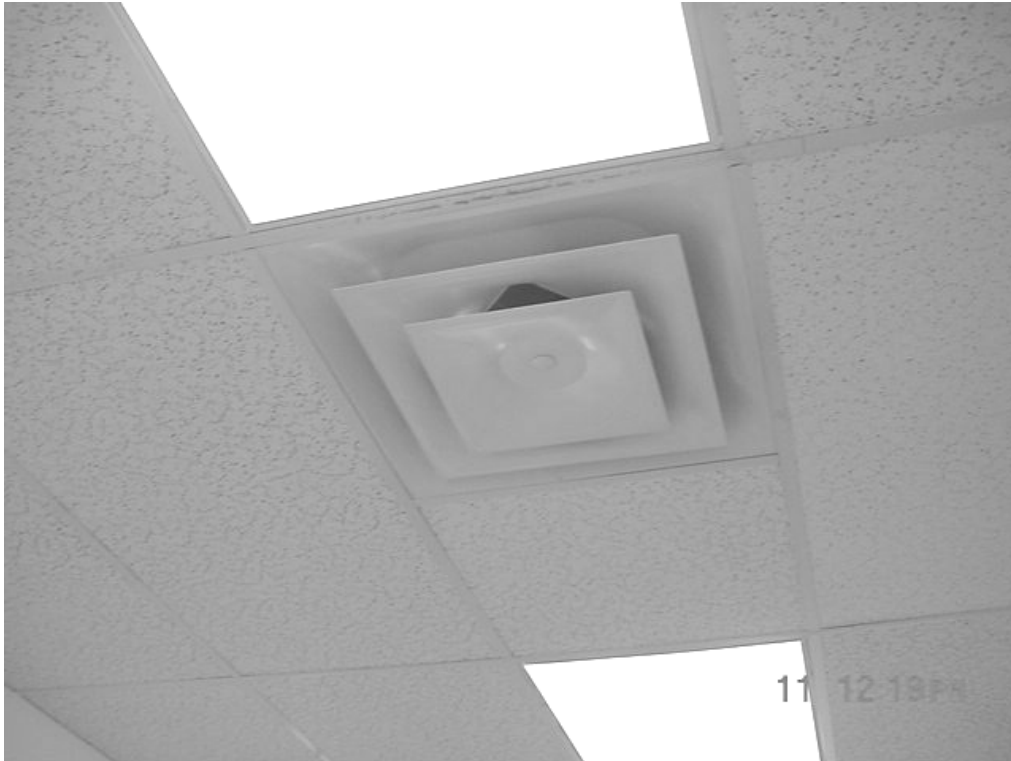
**Picture 2**

**Fresh Air Supply Diffuser**

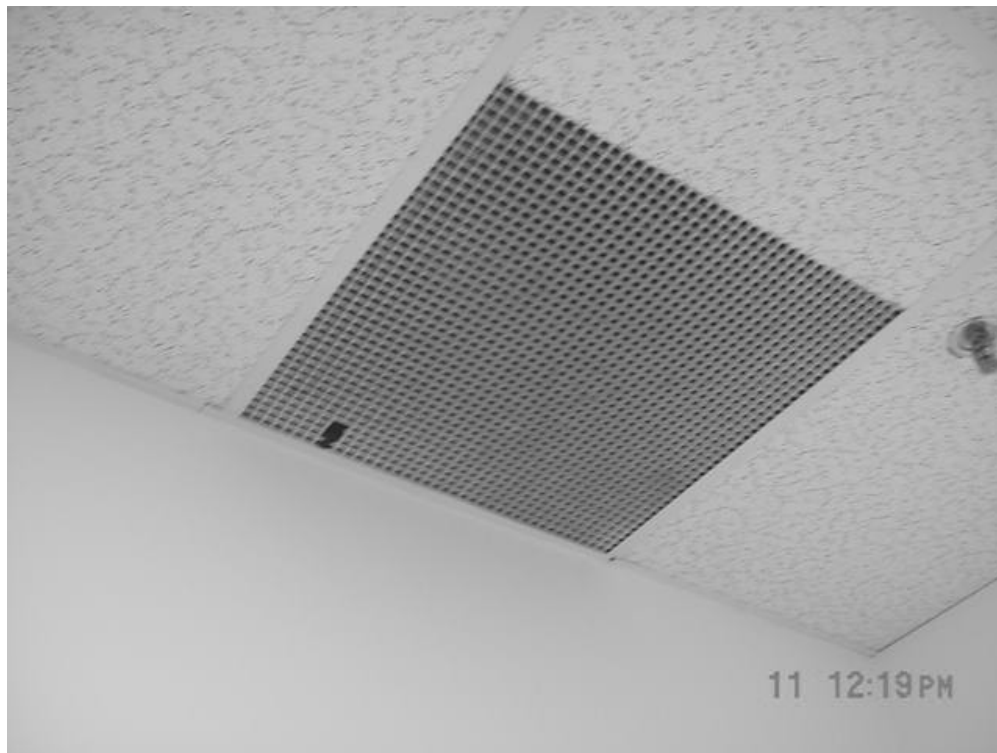
**Picture 3**

**Ceiling-mounted Exhaust Grill**

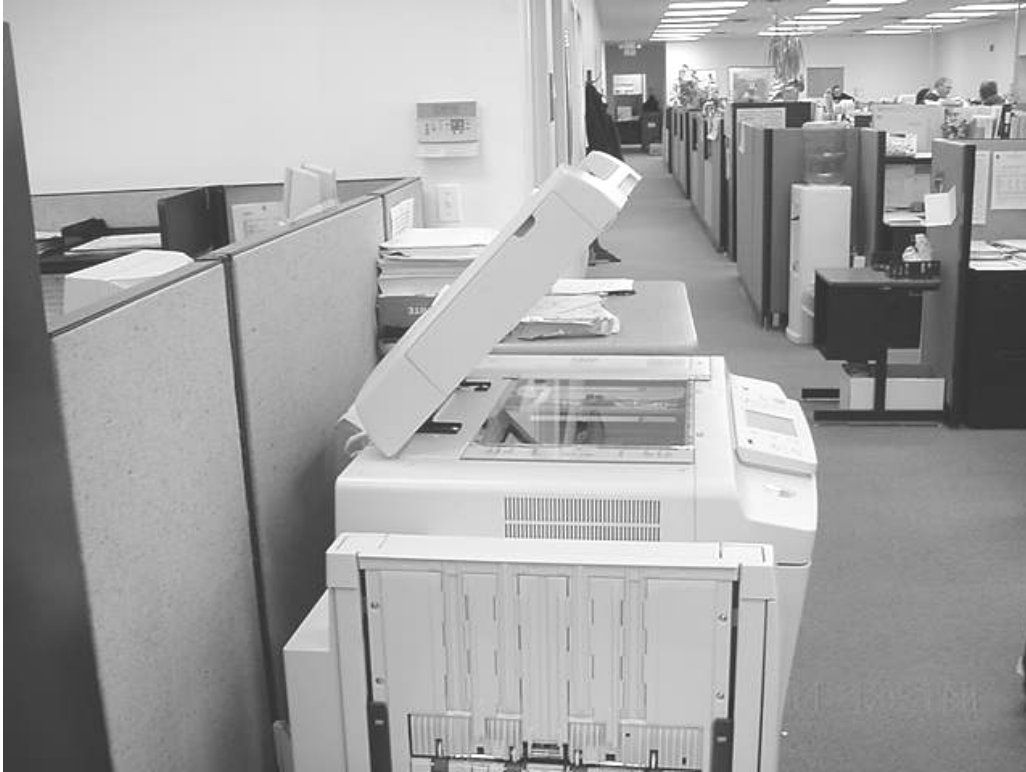
**Picture 4**

Temperature measurements ranged from 67° F to 76° F, which were below the BEHA recommended comfort range in some areas. The BEHA recommends that indoor air temperatures be maintained in a range of 70° F to 78° F in order to provide for the comfort of building occupants. In many cases concerning indoor air quality, fluctuations of temperature in occupied spaces are typically experienced, even in a building with an adequate fresh air supply. Temperature control/comfort complaints were expressed by staff in a number of areas. In some cases thermostats were observed near office equipment such as photocopiers (see Picture 4). Heated air rising from the photocopier could influence the thermostat, which could in turn activate the HVAC system to provide cold air to this area during summer months. In winter, the HVAC system would be deactivated by heated air from the photocopier interacting with the sensors in the thermostat. A large output photocopier was located in a semi-enclosed area that also houses two employees (see Tables). No local exhaust ventilation is located in this area to remove excess heat generated by the photocopier. The close proximity of the

photocopiers to thermostats, in combination with occupants, makes it difficult for the ventilation system to control for comfort.

**Thermostat**

**Thermostat on Wall near Photocopier**

9. Relocate photocopiers and other heat generating office equipment from the vicinity of thermostats (and occupants if possible).
10. Install a door sweep beneath the hallway door in the Hatfield cubicle area to prevent drafts and heat loss.

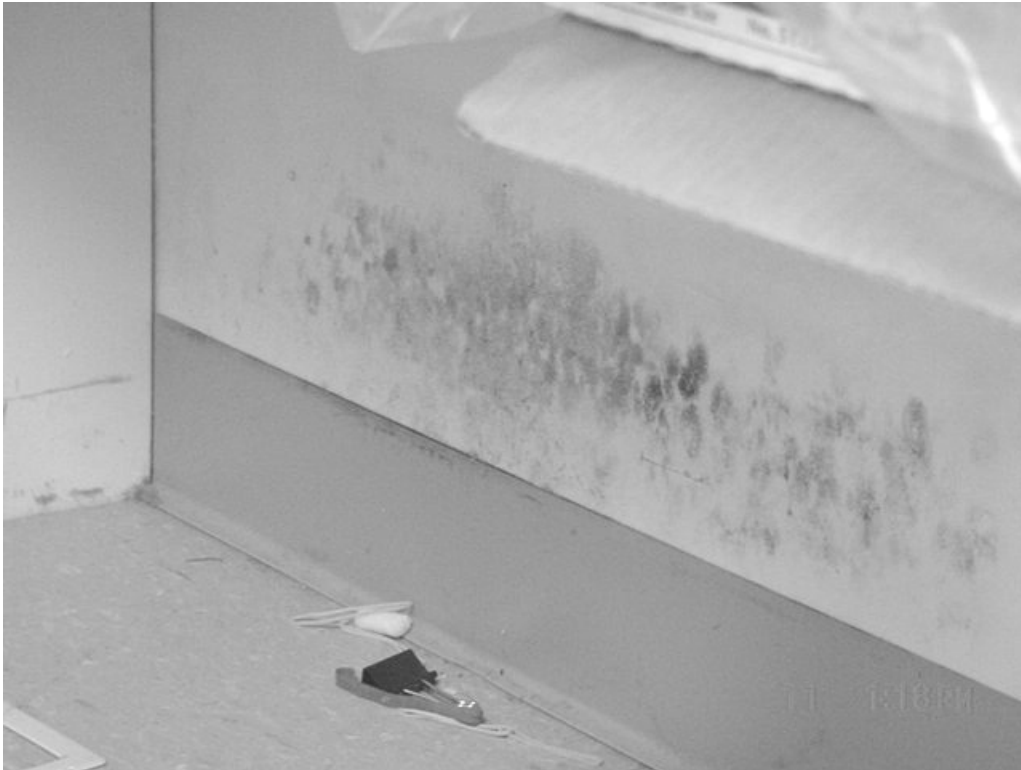
**Picture 5**

Visible mold growth was noted on the gypsum wallboard (GW) in the storeroom near the floor (see Picture 5). Also noted were water stains on cardboard boxes stored on the floor (see Picture 6), which indicates historic water penetration/flooding. DET staff could not recall any water issues/flooding in recent memory. No obvious interior sources of moisture were seen during the assessment. BEHA staff observed conditions along the outside perimeter of the building adjacent to this area to identify breaches in the building envelope, which could provide a source of water penetration. No exterior sources were

Like other porous materials, if GW becomes wet repeatedly it can provide a medium for mold growth. Mold and related particulates can be irritating to sensitive individuals. In order for building materials to support mold growth, a source of water is necessary. Identification and elimination of water moistening building materials is necessary to control mold growth. GW with increased moisture content over normal concentrations may indicate the possible presence of mold growth. Identification of the location of GW with increased moisture levels can also provide clues concerning the source of water supporting mold growth. In an effort to ascertain moisture content of GW, samples were taken in areas most likely impacted by water damage, primarily the at the base of the wall where mold growth was present (see Picture 5), as well as a number of non-affected areas for comparison. As discussed, water content of GW was measured with a Delmhorst, BD-2000 Model, Moisture Detector with a Delmhorst Standard Probe. The probe was inserted into the surface of GW on walls. The Delmhorst probe is equipped with three lights as visual aids to determine moisture level. Readings, which activate the green light, indicate a sufficiently dry level (0 - 0.5%), those that activate the yellow light indicate borderline conditions (0.5 – 1.0%) and those that activate the red light indicate elevated moisture content (> 1%).

**Mold Growth (Dark Staining) on Gypsum Wallboard in Storage Room**

1. Remove and replace any mold contaminated/water damaged GW. This measure will remove actively growing mold colonies that may be present. Remove mold contaminated materials in a manner consistent with recommendations found in “Mold Remediation in Schools and Commercial Buildings” published by the US Environmental Protection Agency, Office of Air and Radiation, Indoor Environments Division, Washington, DC. EPA 402-K-01-001. March 2001. Copies of this document can be downloaded from the US EPA website at: [http://www.epa.gov/iaq/molds/mold\\_remediation.html](http://www.epa.gov/iaq/molds/mold_remediation.html). Removing the water-damaged gypsum wallboard will also give maintenance personnel the opportunity to observe conditions within the wall cavity and to determine any signs of water penetration through breaches of the building envelope.

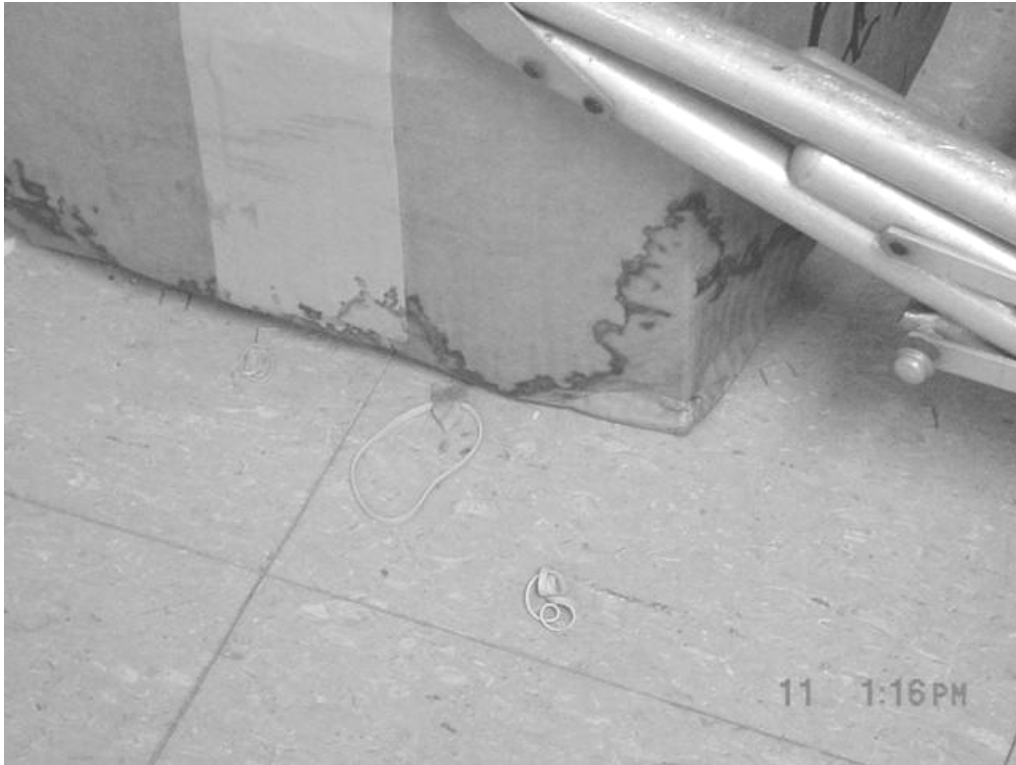
**Picture 6**

**Water Damaged Cardboard Box in Storage Area**

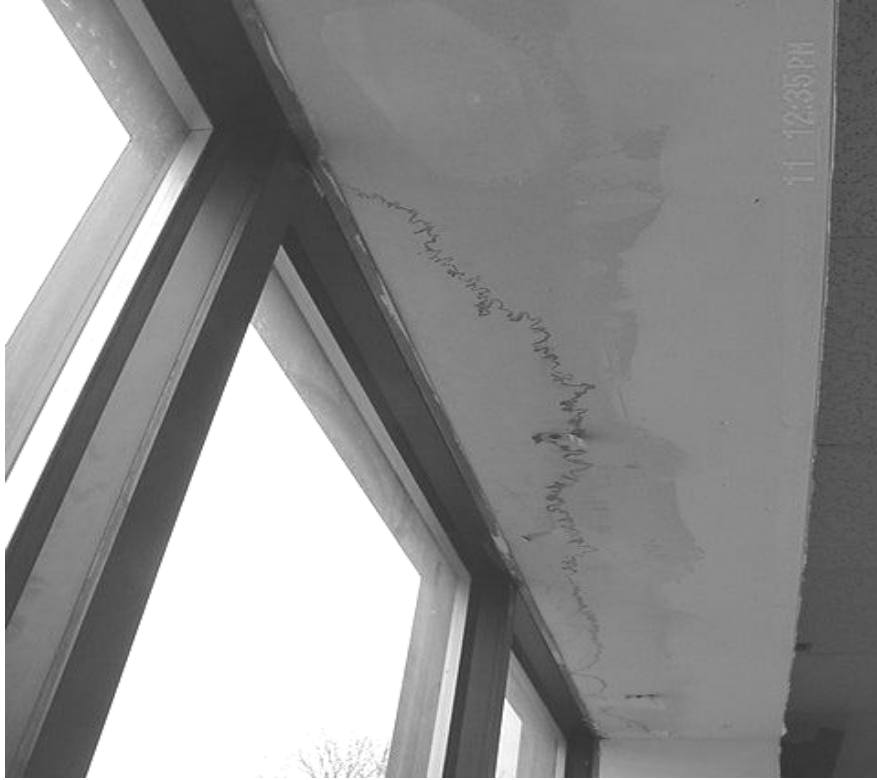
**Picture 7**

Water damage was noted around a windowsill that occupants reported was due to a breach in the exterior wall (see Pictures 7 & 8). BEHA staff conducted moisture readings of the GW and found no elevated moisture content. Also observed in this area was water damage related to plants being placed on the wooden windowsill (see Picture 9). BEHA staff measured moisture content of the wood and found it to be saturated. As stated, porous materials can provide a medium for microbial growth if wetted repeatedly.

**Water Damaged GW Over Window**

13. Repair any water leaks and replace any water damaged building materials (e.g. ceiling tile, GW). Examine the areas above and behind these areas for mold growth. Disinfect areas of water leaks with an appropriate antimicrobial.

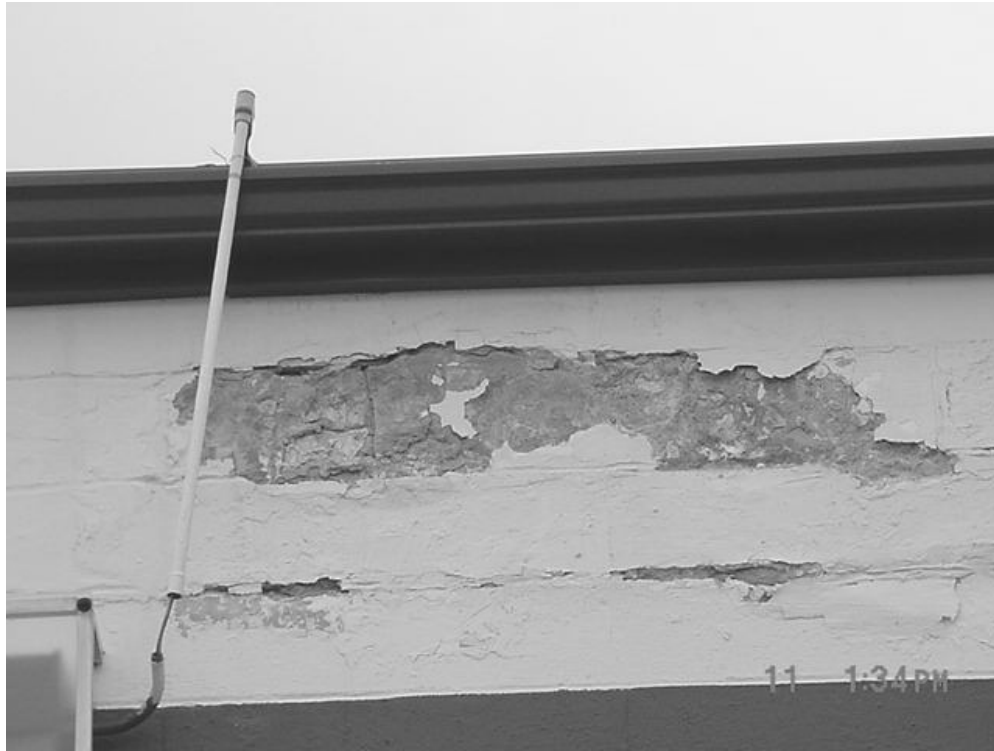
**Picture 8**

**Damaged Exterior Brickwork Associated with Water Damage Near Window in Picture 7**

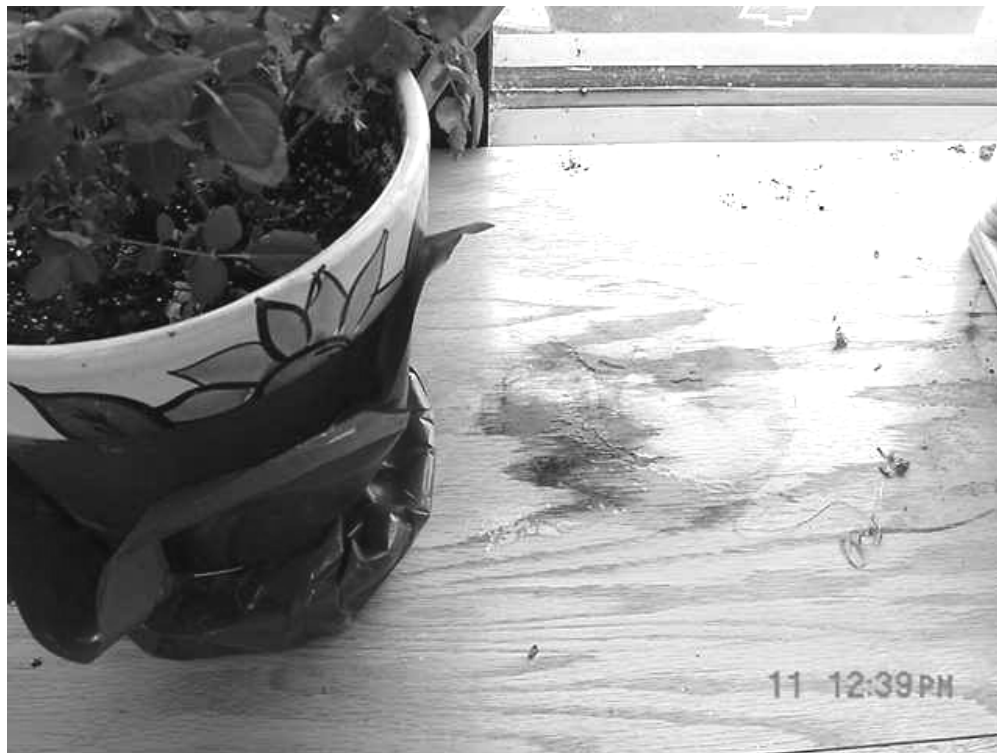
**Picture 9**

**Water Damaged Wooden Windowsill Beneath Plants**

14. Ensure all plants are equipped with drip pans. Examine drip pans periodically for mold growth and disinfect with an appropriate antimicrobial where necessary.

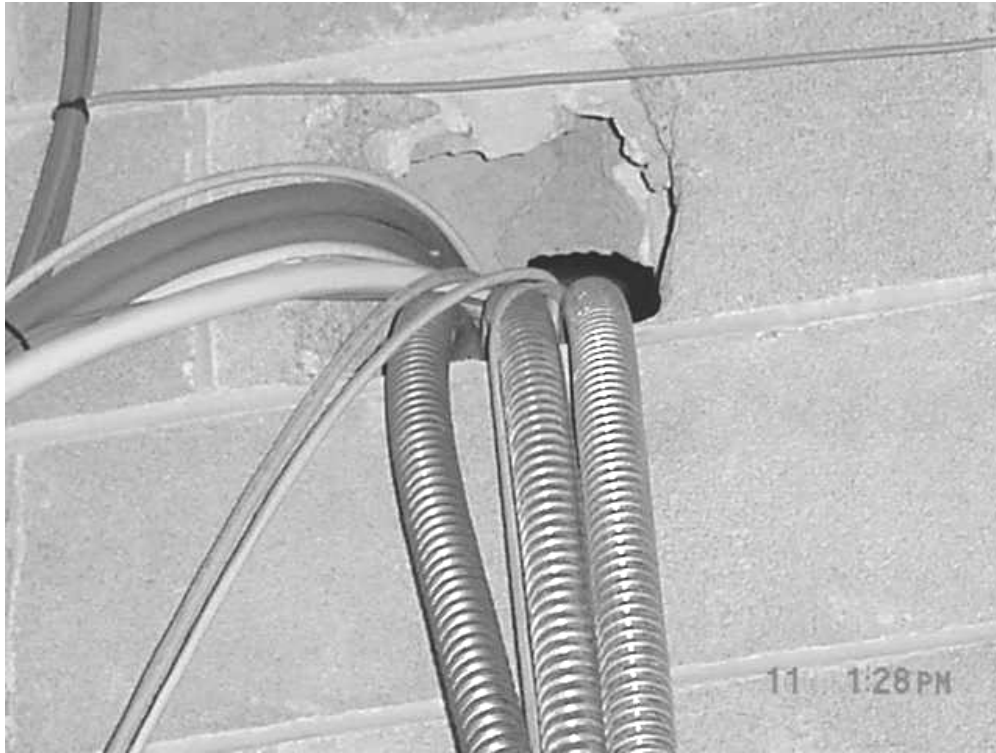
**Picture 10**

A number of other conditions were noted during the assessment, which can affect indoor air quality. A mechanical room adjacent to the DET office area houses a sewerage pumping station. The contour of the land where the DET is located requires the facility to mechanically pump sewerage up gradient to the city system. Complaints of periodic odors were reported in the DET. The mechanical room and the DET area share an adjoining wall. Pipes and wiring were observed traversing the wall between the DET and the mechanical room (see Picture 10). In addition, the metal door to the mechanical room was severely corroded at the bottom (see Picture 11). Under certain wind and weather conditions, the mechanical room can become pressurized. The damaged door to the mechanical room, and holes in ceilings and walls are breaches that can serve as a source and means of egress for odors, fumes, dusts and vapors between the mechanical room and the DET. The mechanical room is equipped with a ceiling mounted exhaust fan. Building maintenance staff should ensure that the fan is operable at all times to draw air away from occupied areas of the DET.

**Utility Hole in Wall of Mechanical Room Leading into the DET**

18. Seal all utility holes and openings in the mechanical (sewer pump) room as well as in the common wall shared with the DET to eliminate pathways for movement of odors into occupied areas.
19. Clean and maintain humidifiers/dehumidifiers as per the manufactures instructions.
20. Discontinue the use of VOC-containing cleaners. Less irritating materials (e.g. soap and water) may suffice to clean occupant areas.
21. For further building-wide evaluations and advice on maintaining public buildings, see the resource manual and other related indoor air quality documents located on the MDPH's website at <http://www.state.ma.us/dph/beha/iaq/iaqhome.htm>.

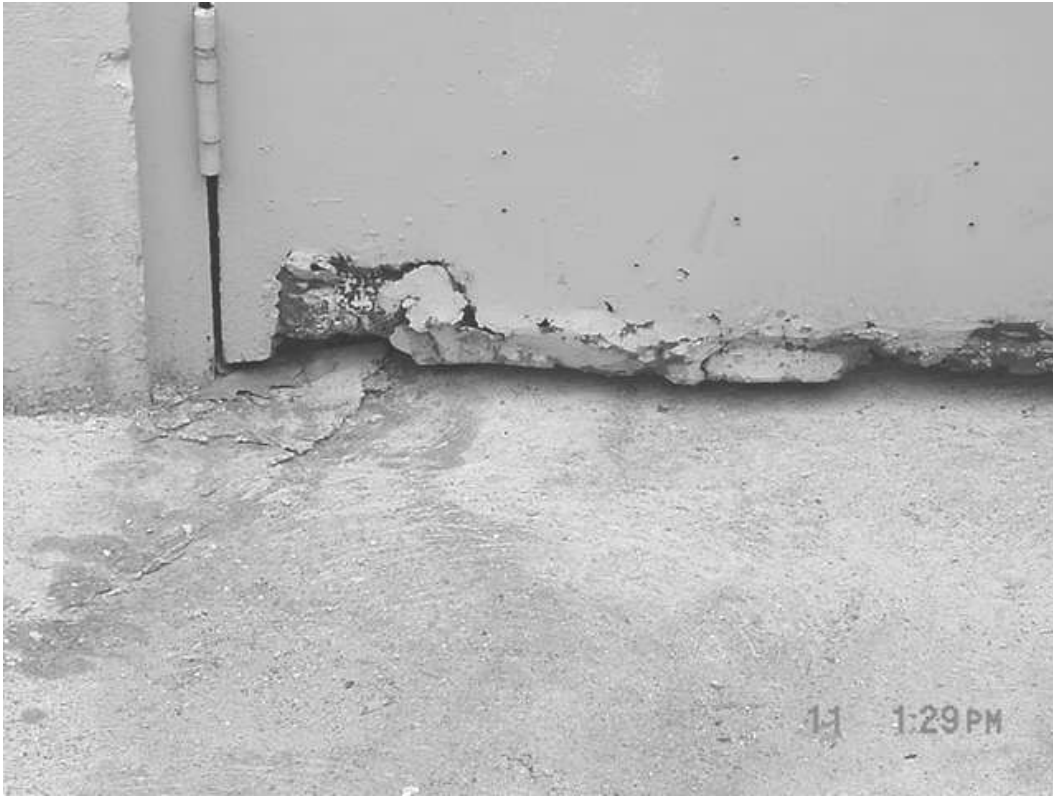
**Picture 11**

**Corroded Metal Door to the Mechanical Room**

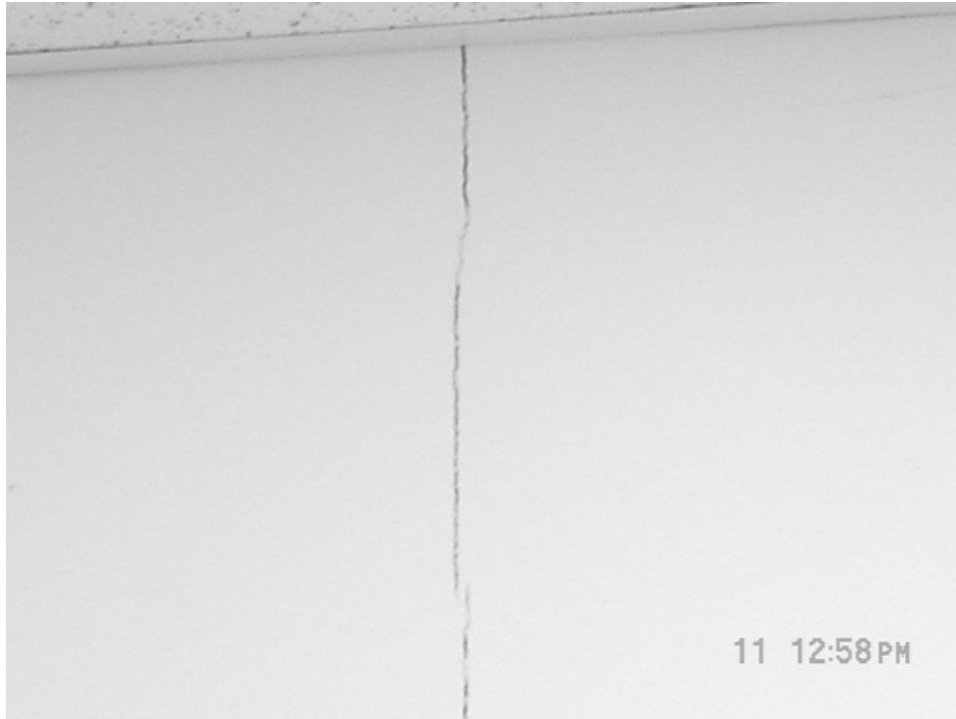
**Picture 12**

Other pathways for odors/drafts to migrate into occupied areas were observed, including spaces under exterior hallway doors, missing ceiling tiles and a large wall crack in the Hatfield cubicle area (see Picture 12). These breaches can all serve as a means of egress for odors, fumes, dusts and vapors between areas.

**Large Wall Crack in Hatfield Cubicle Area**

2. Ensure the exhaust fan for the mechanical room is operating to draw odors away from the DET.
3. Seal wall crack shown in Picture 12.
4. Repair/replace restroom exhaust motors.

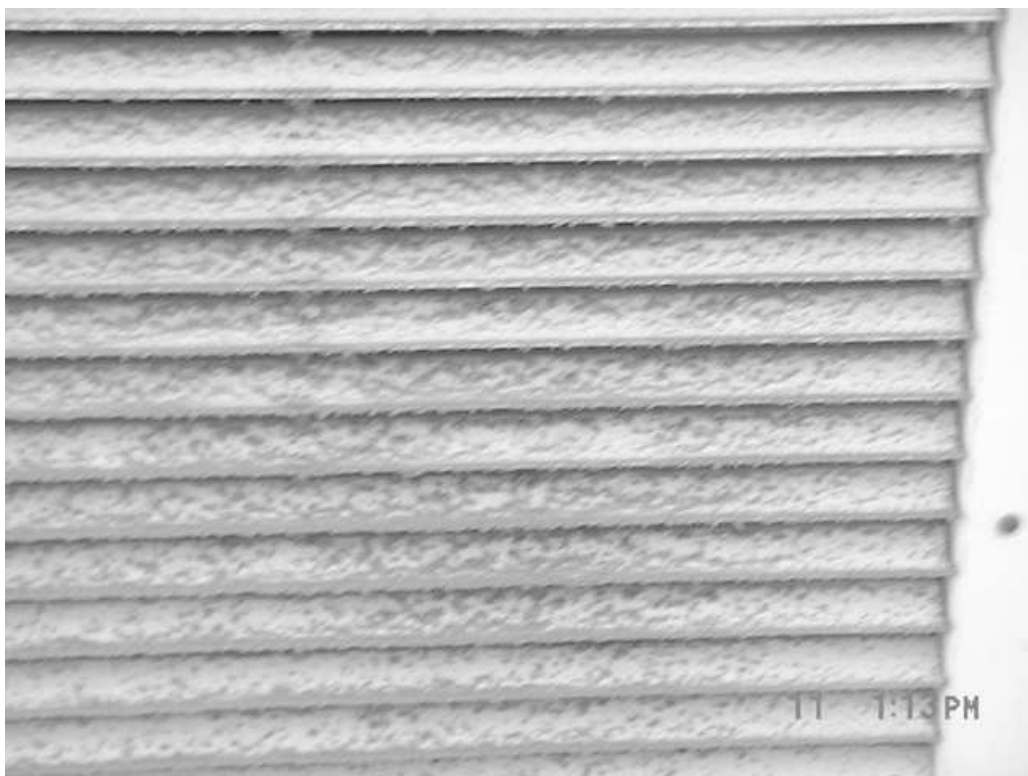
**Picture 13**

Building occupants reported on-going complaints of eye irritations. There are a number of conditions that can contribute to this complaint. Accumulation of dust on flat surfaces was noted. Dust can be irritating to the eyes, nose and respiratory tract. The large amount of items stored provides a means for dusts, dirt and other potential respiratory irritants to accumulate. These stored items, (e.g. papers, folders, boxes) make it difficult for custodial staff to clean. A number of exhaust and return vents were also noted with accumulated dust (see Picture 13). If exhaust vents are not functioning, back drafting can occur, which can re-aerosolize dust particles.

**Accumulated Dust on Exhaust Vent**

12. A coordinated effort between, DET management, staff and building management and maintenance personnel should be made to conduct cleaning of offices, common areas and cubicles/ personnel work spaces to prevent the accumulation of settled dust.

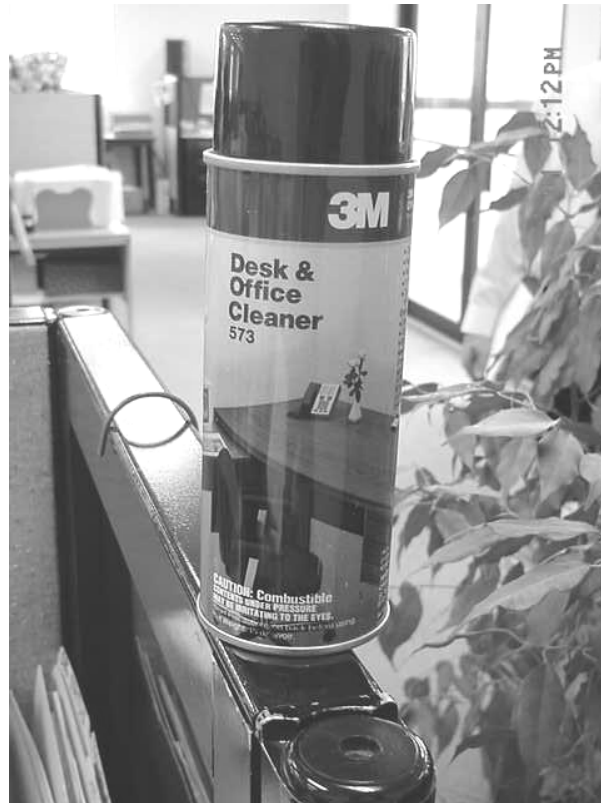
**Picture 14**

Lastly, DET staff frequently use VOC-containing cleaning materials (see Picture 14) to clean their personal work areas. This material contains several VOCs (e.g. isopropyl alcohol and monoethanolamine) that can be irritating to the eyes, nose and throat (3M, 2000) (see Picture 14).

**Spray Cleaner Used in the DET, Note Label Says May Cause Eye Irritation**
